STATUS REPORT

May 12, 2010

SUBJECT: Museum Status Report

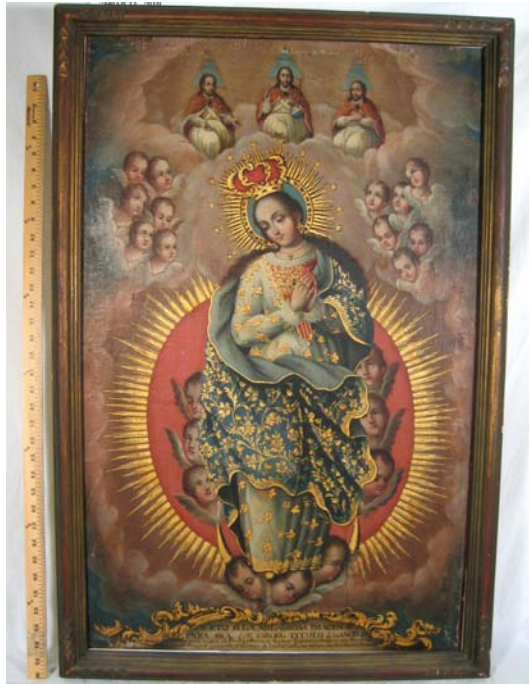
Before Treatment

Through the generous support of donors, the painting titled “The Coronation of the Blessed Virgin Mary, Queen of Heaven and Earth” has been removed from display within the Sacristy of the Serra Chapel for conservation. The painting has numerous holes within the canvas, paint loss and tears. Additionally, the animal glue used to adhere the canvas to the backing board support had lost its adhesion and is no longer firmly holding the canvas flat, which is promoting paint loss.

The photo to the left shows holes, losses, poor framing support and dulled varnish. The detailed photos to the right show more specific damage. The top photo shows areas of paint loss in the dedication text at the bottom of the artwork. The bottom photo shows budging of the canvas where tape has been placed behind the canvas to stabilize a tear. The tape has distorted the canvas causing a secondary tear in it.

The extent of damage and problematic backing of the canvas meant that the painting needed to be conserved to prevent future tearing and image loss. The services of painting conservator, Aneta Zebala, were secured for this project. The painting is currently undergoing conservation and should be completed by mid June.

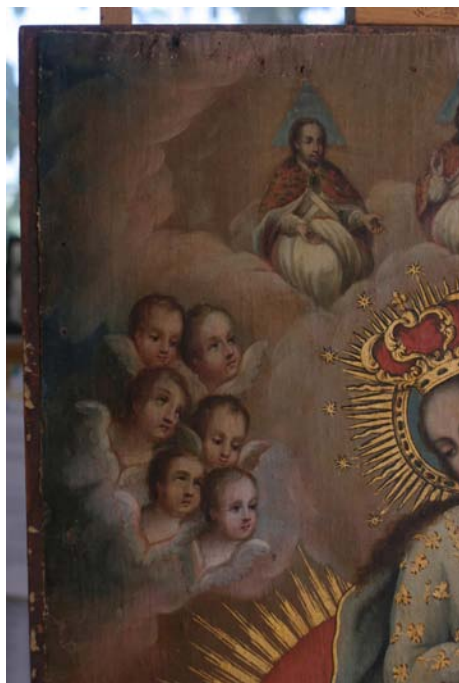
During Treatment

The photo to the left shows the painting during treatment after an initial cleaning to remove grime and deteriorated varnish.

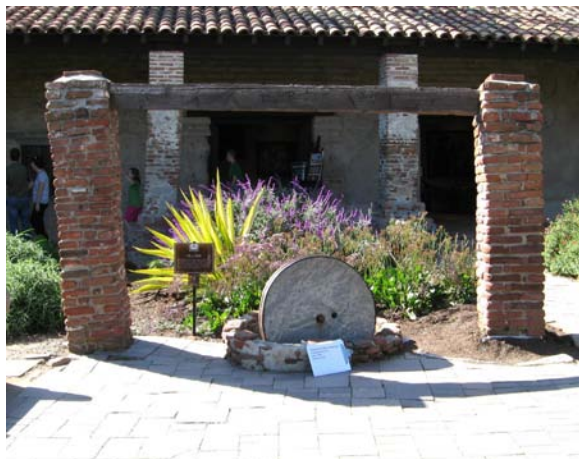
A condition assessment was performed in mid February when the masonry columns were found to be leaning more notably than previously witnessed. Upon inspection it became evident that entire mill site was built directly onto the ground with no foundation or gravel drainage bed. As a result, the ground on which the olive mill is situated on has experienced uneven settling over time and the pillars are visibly leaning. Settling appears to be contributed to water draining direct below the pillars and the collapse of decaying roots from a pepper tree removed years earlier.

Pictured in the photo on the left is the olive mill site with the columns leaning in opposing directions due to earth compaction and settling. The photo on the right documents cracking within one of the columns.

Monitoring of the site will continue until the rain season is completed, after which, any recommendations to be made will be forwarded to Mechelle Lawrence-Adams. The next page shows images of the olive mill.
